# **Debris/Ice/TPS Assessment and Integrated Photographic Analysis of Shuttle Mission STS-81**

*Process Engineering/Mechanical System Division/ET-SRB Branch,  
Kennedy Space Center, Florida*

**12 January 1997**

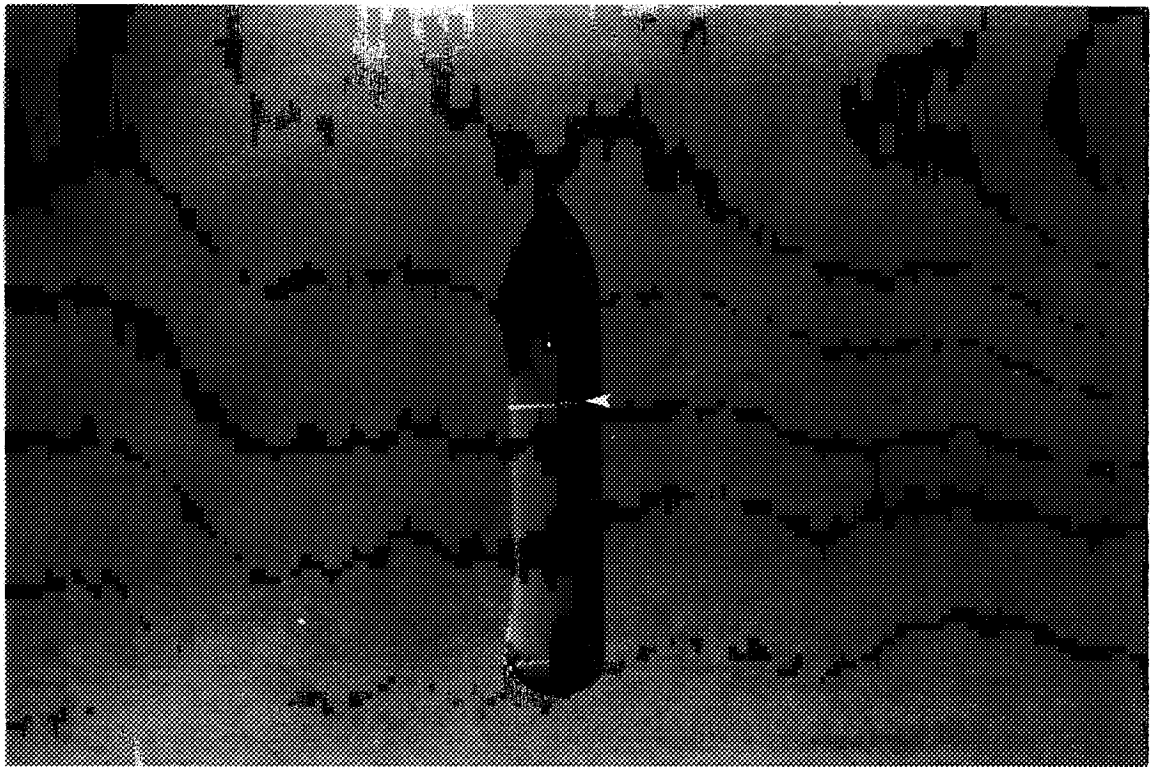
Figure 2.4.2 (A) Divots on the LH2/Intertank Closeout Flange

Eight divots are clearly visible on or very near the LH2/intertank closeout flange. Charring and small "popcorn" divots are visible on the ET aft dome. The normal SRB separation motor burn scars and aero heating marks are visible on the ET TPS. The ET was measured to be 2.3 kilometers from the Orbiter on the first ET picture. The ET separation rate was calculated to be 4.2 meters per second (typical of previous missions). The new intertank access door was not visible on the handheld photography.
